**RZESZOW UNIVERSITY
OF TECHNOLOGY**

Heat resistance of SiC/SiC ceramic composites

DOCTORAL THESIS

This work was carried out as part of a scientific collaboration with MTU Aero Engines
Polska Sp. z o.o.

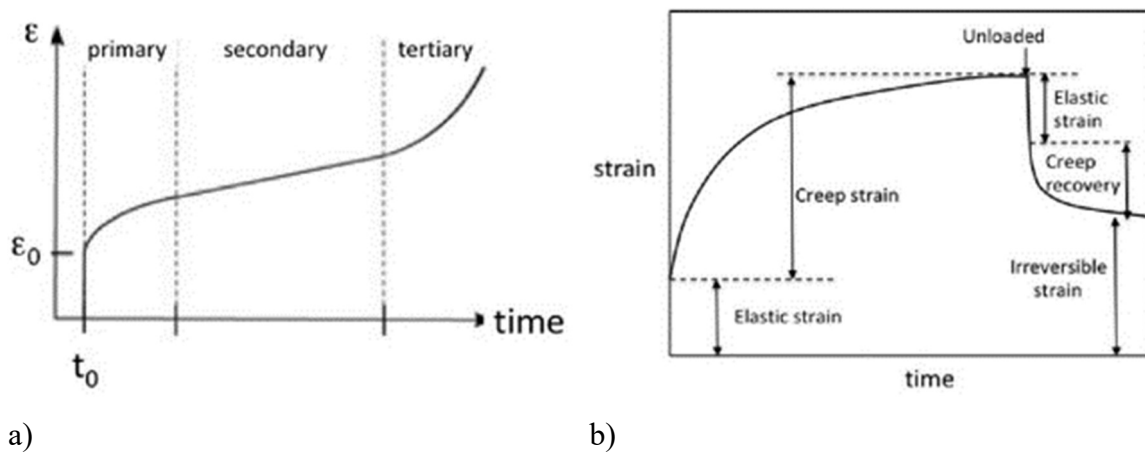
Figure 4 Schematic illustrations of the creep curves obtained from tests conducted under condition of constant load (a) and constant strain over time (b) [53]

After the load is removed, (Figure 4 b) can be observed changes of deformation. The first is elastic deformation, which is instantly recovered and the sample returns to its original shape. The second is time-dependent reversible deformation that occurs during primary creep, where the material slowly returns to its initial state over time. Lastly, there is permanent deformation observed during secondary creep, which does not recover and remains in the material even after the load is removed.

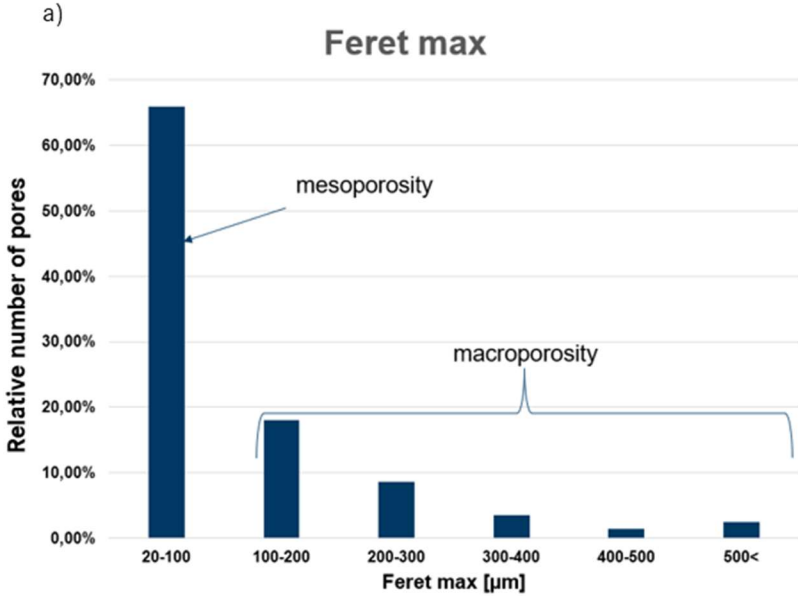
Figure 18 Pore size distribution depending on the Feret Max a) in the SiC/SiC composite, b) mesoporosity, c) macroporosity

During the analysis the focus was on parameters such as area of pores, area fraction of pores, Feret Max, Feret Min and circularity. In total, over 4000 individual pores were analyzed. Most of them can be classified as mesoporosity (Figure 18 a). The friction of mesoporosity (20-100µm) in the area of all porosity in the material was below 10%. The area friction of pores larger than 500 µm is equaled to 21%. In mesoporosity the most frequently observed were pores with Feret Max 20-40 µm (59%) and the most rarely were pores with Feret Max 80-100 µm (8%). In macroporosity the most frequent were pores with Feret Max 10-200 µm (52%) and the most rare were pores with Feret Max 400-500 µm (4%) (Figure 18 b and c).

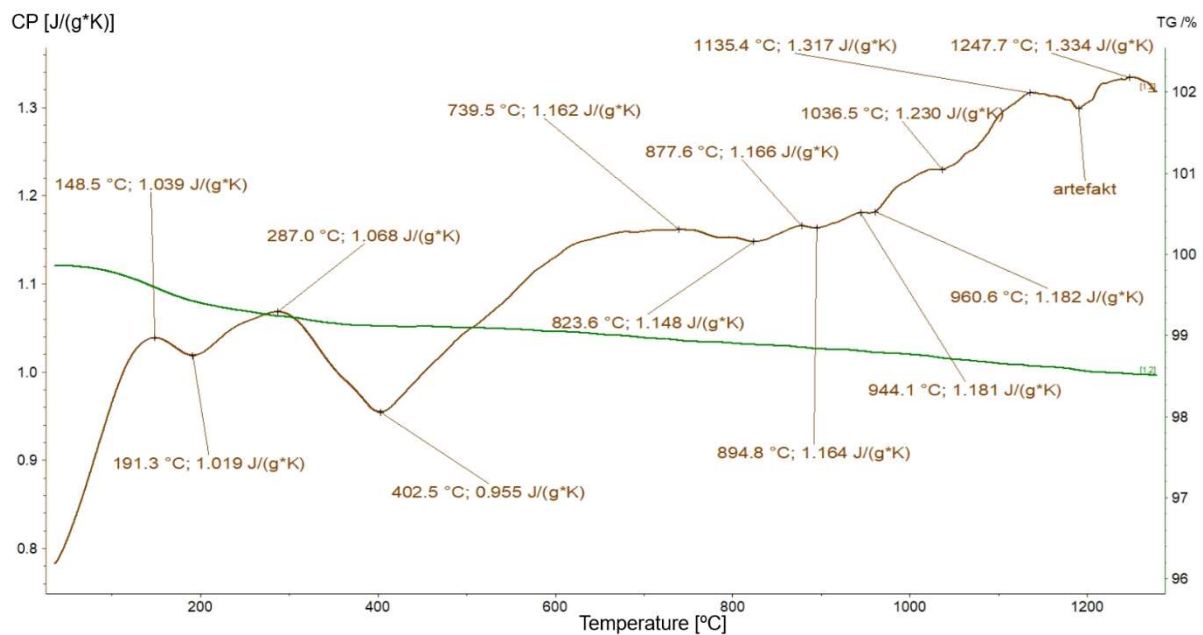
Figure 35 DSC and TGA curves for S200H composite tested at the temperature range 0-1200 °C

The thermal behavior of the SiC/SiC composite, consisting of a silicon carbonitride (SiNC) matrix and SiC fibers coated with boron nitride (BN) and silicon nitride (Si_3N_4), was investigated using simultaneous thermogravimetric analysis (TGA) and differential scanning calorimetry (DSC). The DSC curve complements the TGA data by providing insight into the thermal events associated with these processes (Figure 35).
