**THE FACULTY OF
MECHANICAL ENGINEERING
AND AERONAUTICS**
RZESZOW UNIVERSITY OF TECHNOLOGY

Heat resistance of SiC/SiC ceramic composites

DOCTORAL THESIS

This work was carried out as part of a scientific collaboration with MTU Aero Engines Polska Sp. z o.o.

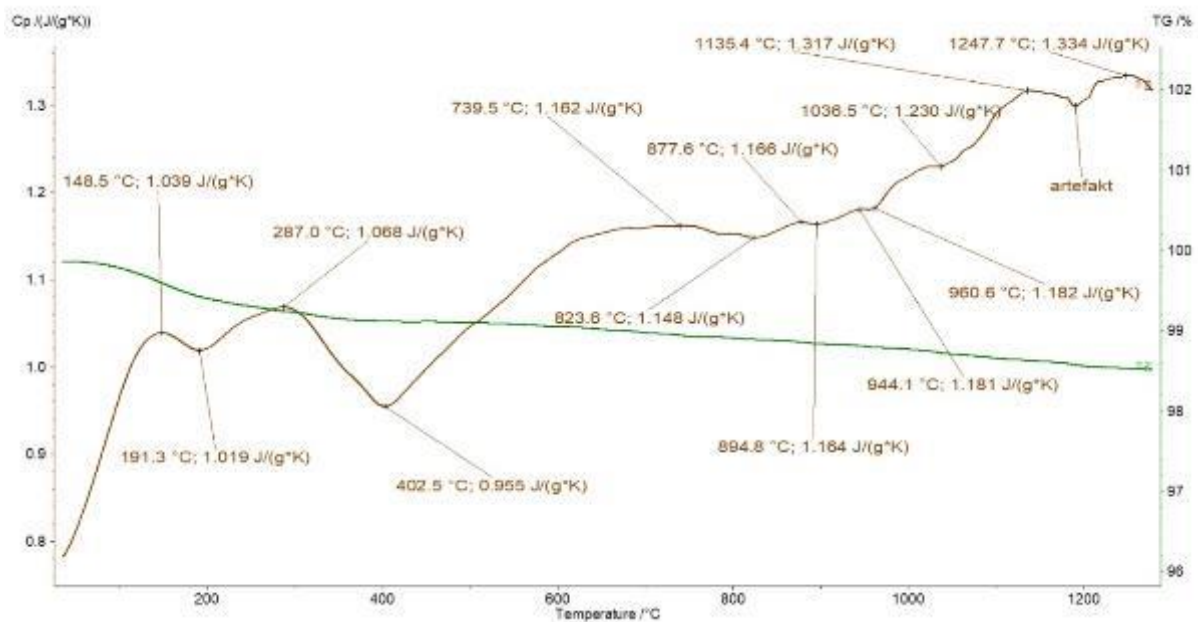
Figure 35 DSC and TGA curves for S200H composite tested at the temperature range 0-1200 °C

The thermal behavior of the SiC/SiC composite, consisting of a silicon carbonitride (SiNC) matrix and SiC fibers coated with boron nitride (BN) and silicon nitride (Si₃N₄), was investigated using simultaneous thermogravimetric analysis (TGA) and differential scanning calorimetry (DSC). The DSC curve complements the TGA data by providing insight into the thermal events associated with these processes (Figure 35).

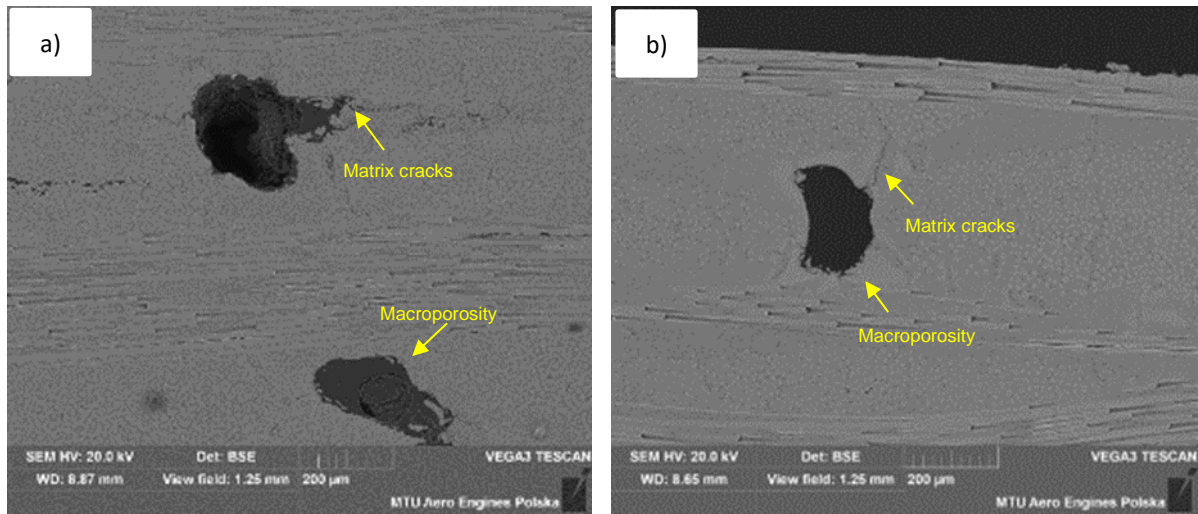
Figure 52 Macroporosity in SiC/SiC composite tested at 980°C for a) 40h and b) 80h

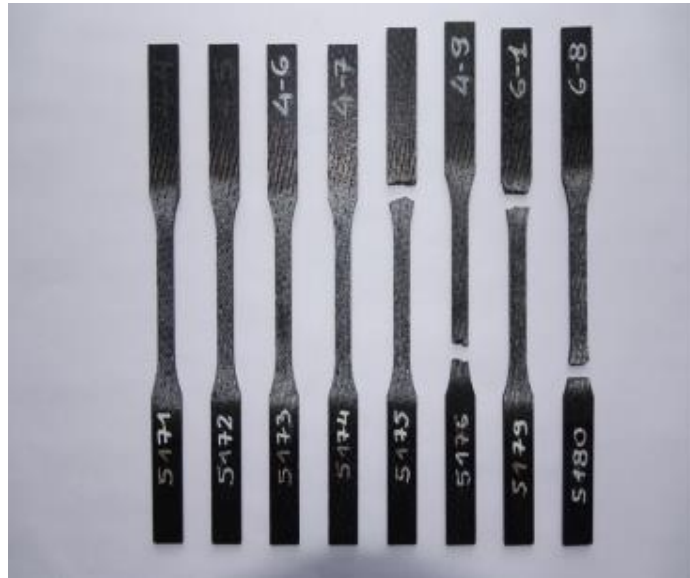
Figure 64 Samples after creep testing in the temperature 980 °C

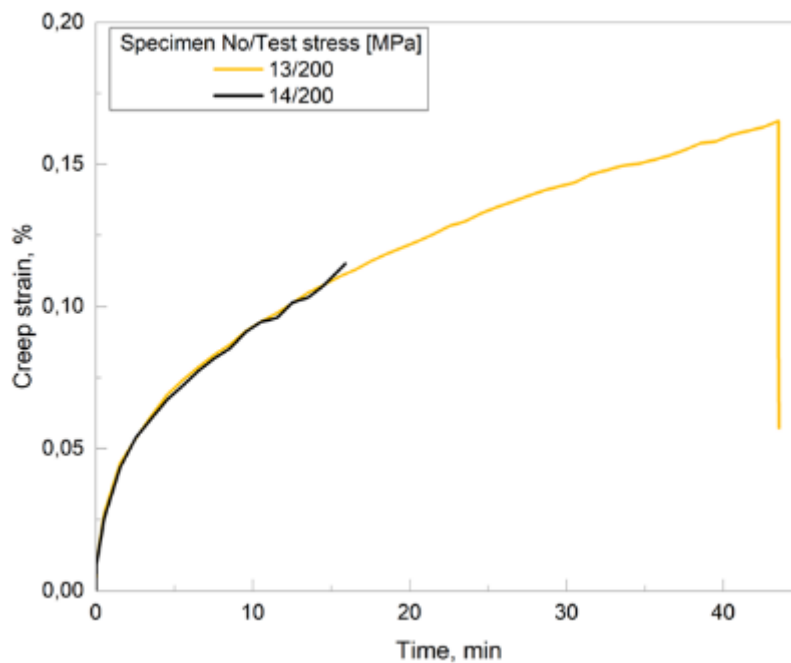
Figure 71 Strain/time creep curves of samples 13 and 14 tested at 1100 °C
